Skidabrader

Hydroplane and Skid Resistance Demo 7/ 29/ 10

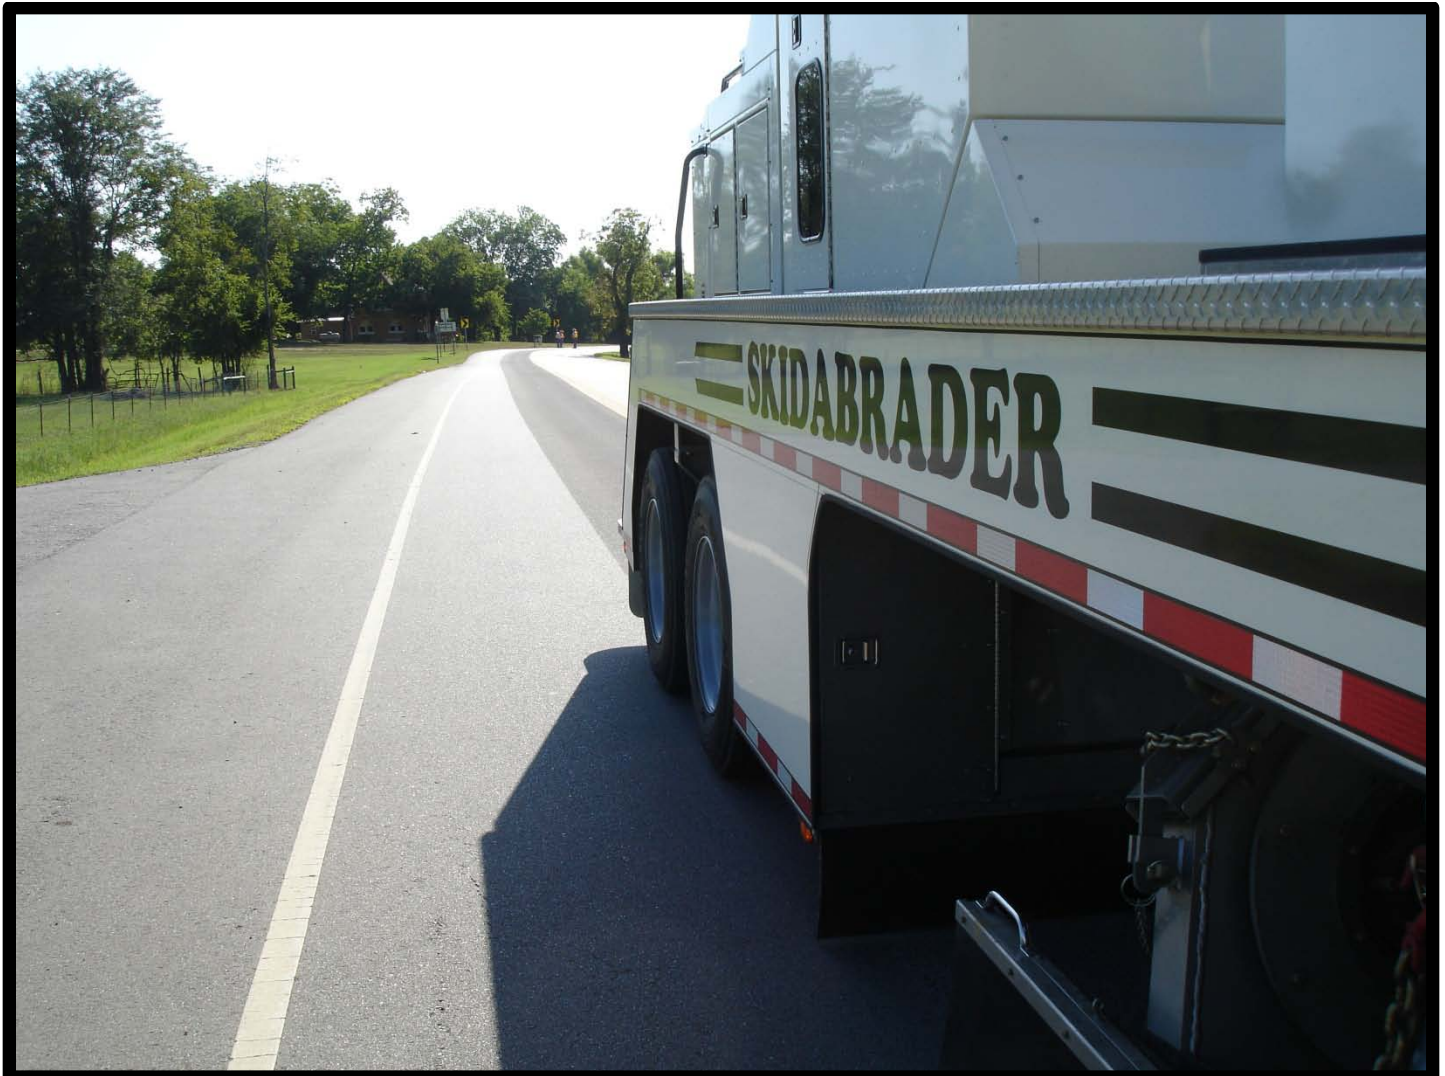
A 1000' two lane asphalt section was Skidabraded to remove 8500# (approx. 3 to 4 cu. Yd.) of oxidized surface matrix from 2,350 sq. yds. of road surface. This had 2 desirable effects. It **created new drainage channels for hydroplaning resistance**. It also **exposed and etched new points of the original aggregate for skid resistance**. Drainage tests were done with an ASTM E-2380 outflow meter. Skid tests were done with an ASTM E-274 test unit using both the E-501 treaded tire and the E-524 bald tire.

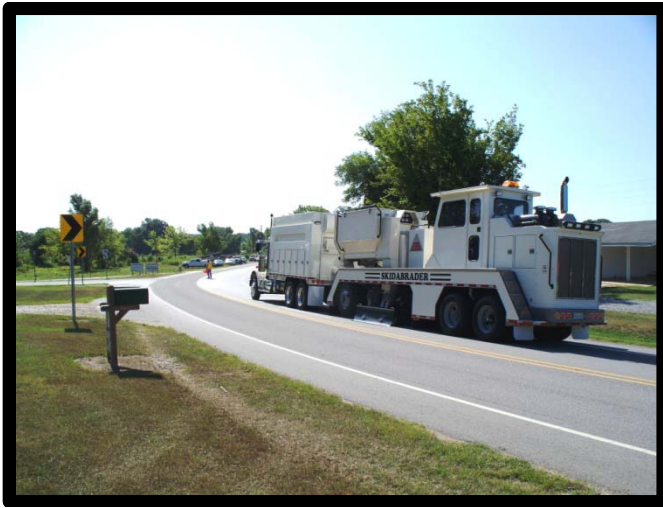
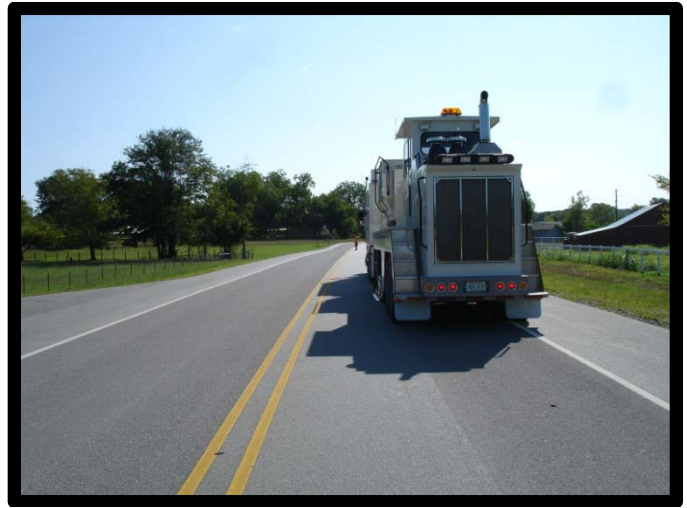
Test Tire		7/28/2010	7/29/2010		
		Before	After		Improvement
South Bound Lane					
0 - 250 Ft.	ASTM E-524 Bald Tire	21.75	59.88		175%
250 - 500Ft.	ASTM E-501 Treaded Tire	36.93	72.42		96%
500 - 750 Ft.	ASTM E-524 Bald Tire	12.99	55.35		326%
750 - 1000 Ft.	ASTM E-501 Treaded Tire	36.07	68.43		90%
North Bound Lane					
0 - 250 Ft.	ASTM E-524 Bald Tire	16.72	58.72		251%
250 - 500Ft.	ASTM E-501 Treaded Tire	38.10	64.59		70%
500 - 750 Ft.	ASTM E-524 Bald Tire	17.36	60.18		246%
750 - 1000 Ft.	ASTM E-501 Treaded Tire	30.89	64.95		110%
	Average Bald Tire Test	17.2	58.53		249%
	Average Treaded Tire Test	35.49	67.59		91%
Hydrotimer Tests					
Average Outflow Time		22 Seconds	6 Seconds		266%

Initial tests of the unimproved surface show a difference between the bald and treaded tire of **17.20 to 35.49, or roughly double**. On problem pavements that have a wide variance between the bald and treaded tire tests, such as this, a **lack of surface drainage** is indicated. The outflow tests confirm that to be the case on this test section. **The Skidabradar restores surface drainage**, therefore the percent of improvement shown after Skidabrading with the bald tire is obviously greater than that of the treaded tire.
