# Surface Retexturing, Rejuvenation Boost N.C. Interstate Performance

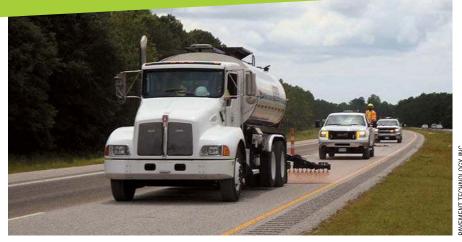
On I-40 near Wilmington, N.C., Reclamite maltene rejuvenator is applied with a Bear Cat computercontrolled 2,500 gal distributor truck

Following surface abrasion, the Dynatest equipment again measured and recorded surface friction to verify the performance requirement of the specifications. Immediately after the second friction testing the Reclamite maltene rejuvenator was applied with a Bear Cat computer controlled 2,500 gal distributor truck.

strip applications, was 0.06 gallons per square yard. After the rejuvenator was given time to be fully absorbed by the textured pavement surface, a period of about 30 minutes, the Dynatest equipment again measured surface friction for verification that the pavement was ready to accept traffic. In all cases the treated sections were open to traffic within 30 minutes.
